Loch Kemp Storage - EIA Report (Additional Information)

AI Appendix 3.5: Draft Borrow Pit Screening Assessment (Revised)

September 2024

Borrow Pit Screening Assessment

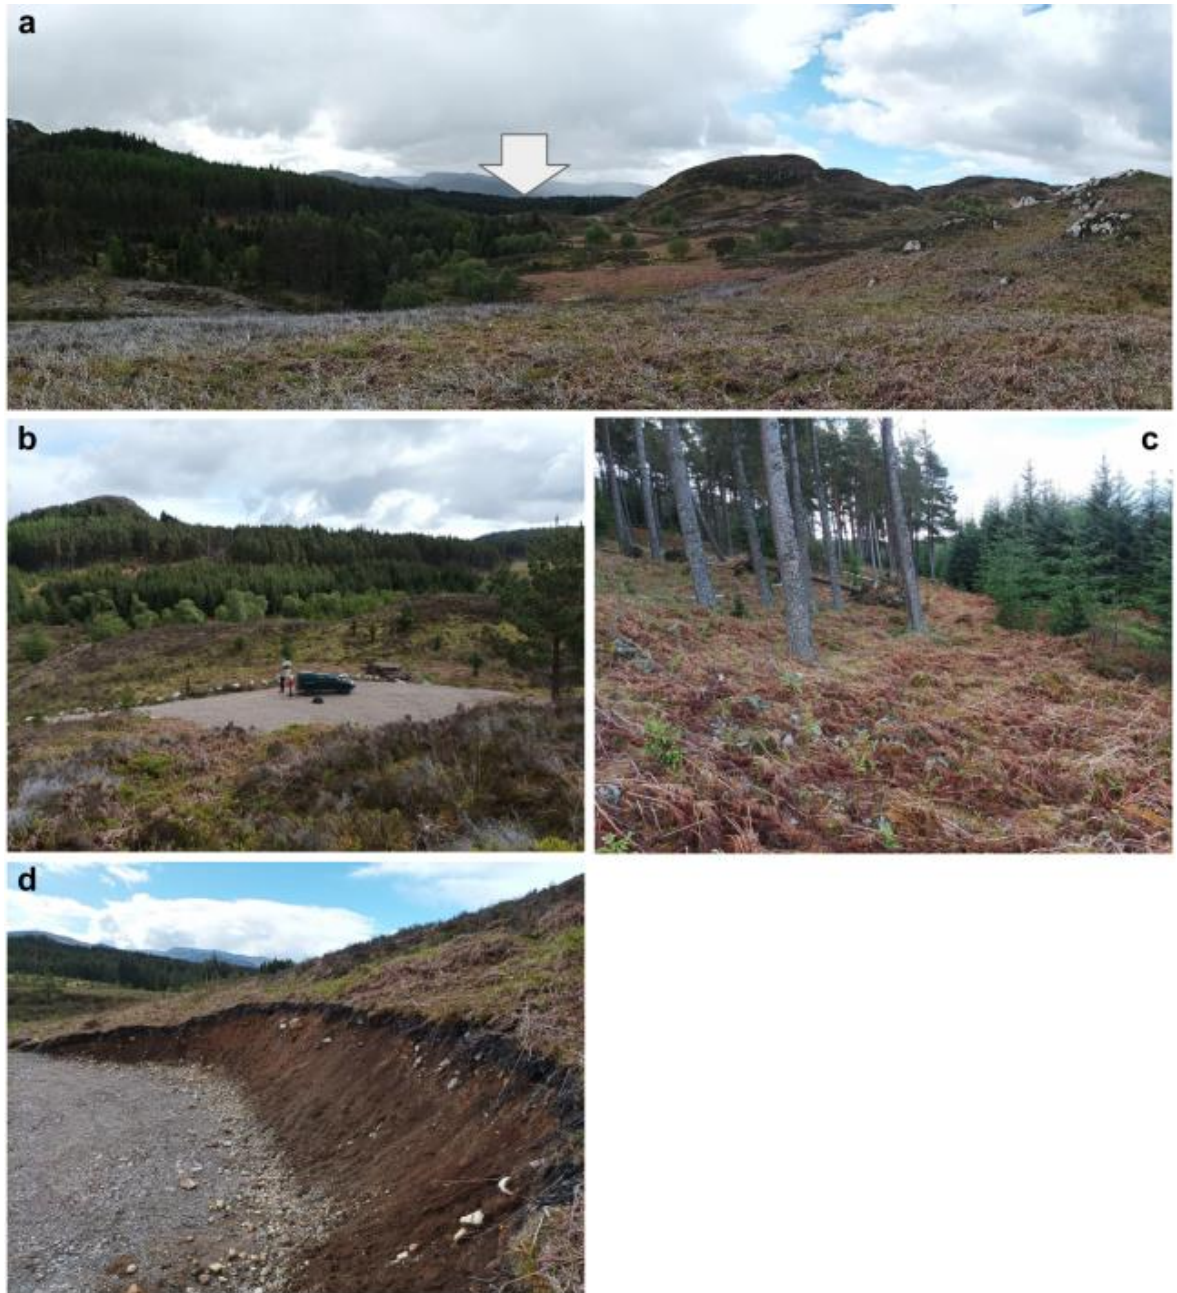
Figure 1: Dam Site 4 (View toward SE showing SW and NE), Quaternary Soil cover

The superficial deposits of the entire site comprise of Quaternary soil cover, predominantly hummocky glacial deposits and peat as displayed in Figure 1. The superficial geological map for the site is attached to this report in Appendix A. The published mapping was confirmed by subsequent site surveys.

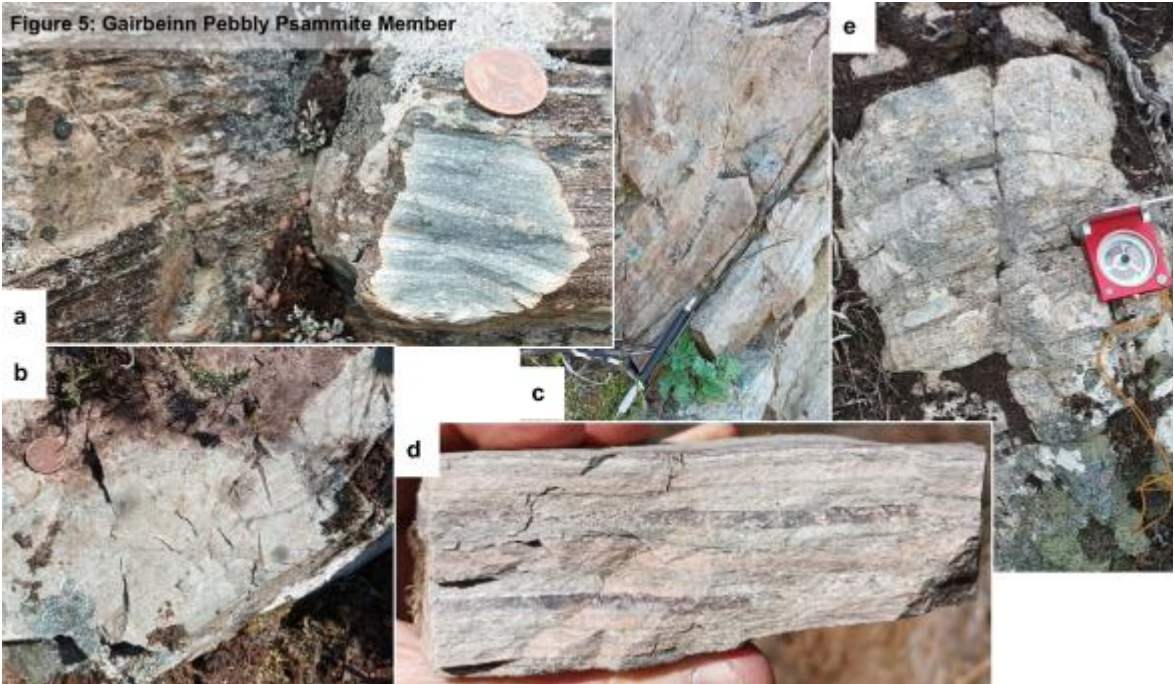
Figure 3: Gairbeinn (Pebbly) Psammite (GAIR-PSAP)

environment, whereas the Loch Laggan sediments reflect progressive deepening of a marine environment and turbidites. The two subgroups reach total thicknesses of 1,400 m (Loch Laggan) and approximately 700 m (Gairbeinn, Haselok et al., 1982), of which, in the field area, only some tens to hundreds of meters are represented. In the stratigraphic record, the two units are separated by Coire nan Laogh semipelite, which suggest a tectonic juxtaposition in the field area. This likely happened during a period of Ordovician tectono-metamorphism about 460-470 Ma ago. The field area is bordered to the NW by Loch Ness, which covers the Great Glen Fault, a long-lived tectonic lineament of great significance in the Caledonian orogeny. The strike-slip fault has experienced several phases of activation, with the oldest being sinistral displacements accumulated between 428 and 390 Ma ago (Stewart et al., 1999) and the most recent one a phase of dextral displacement during the Cenozoic in association with the opening of the North Atlantic (Underhill & Brodie, 1993, Le Breton et al., 2013). Examples of the aforementioned bedrock formations are displayed in Figure 2 and Figure 3.

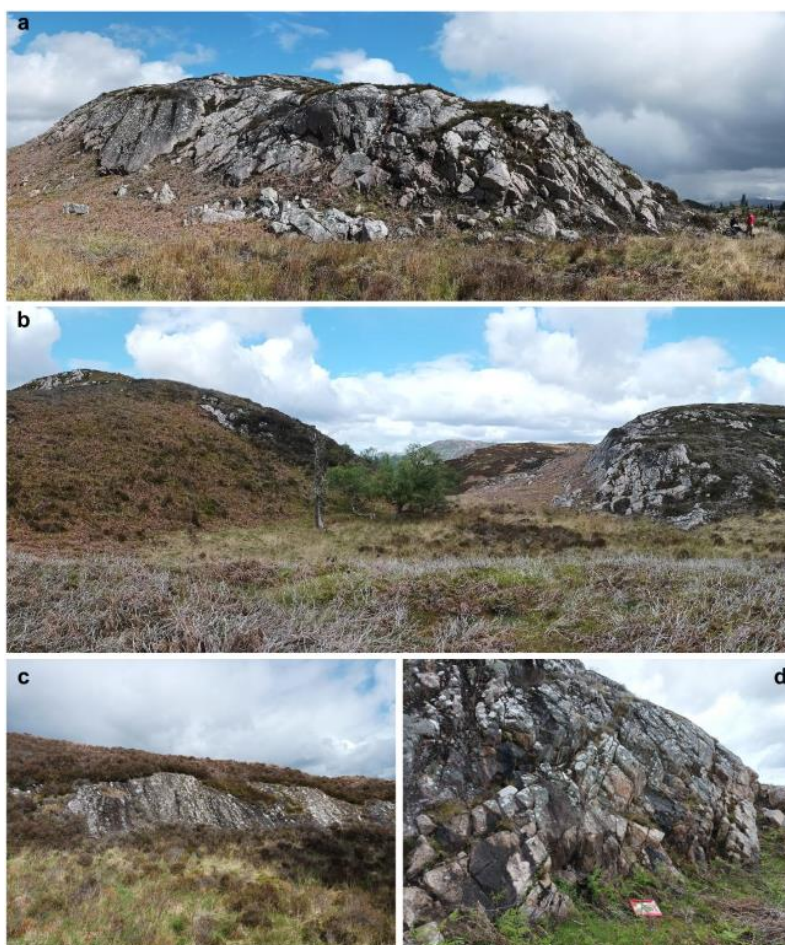
Figure 4: Granitoid rock (FOY-GD), Blocky appearance, slight surface weathering, No evidence for faulting

The bedrock units (granitoids) of FOY-GD (as detailed in Table 1) appear to be blocky with fewer discontinuities and dipping mostly NW as can be seen in Figure 4 and Figure 5.

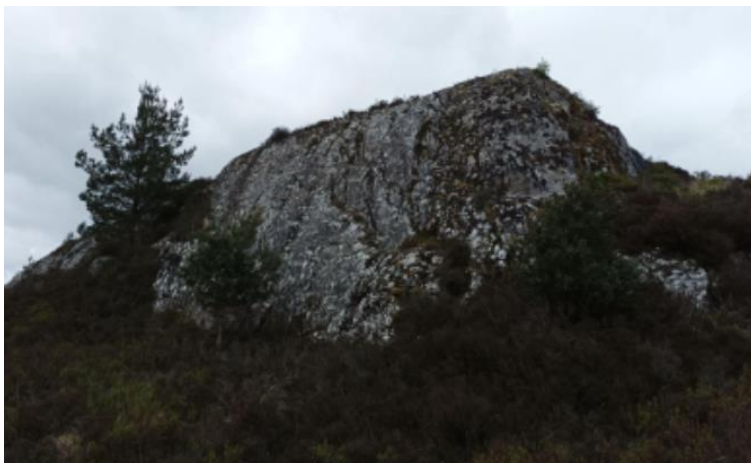
Figure 5: Compact rock with pervasive jointing producing blocks of <1 m³ volume

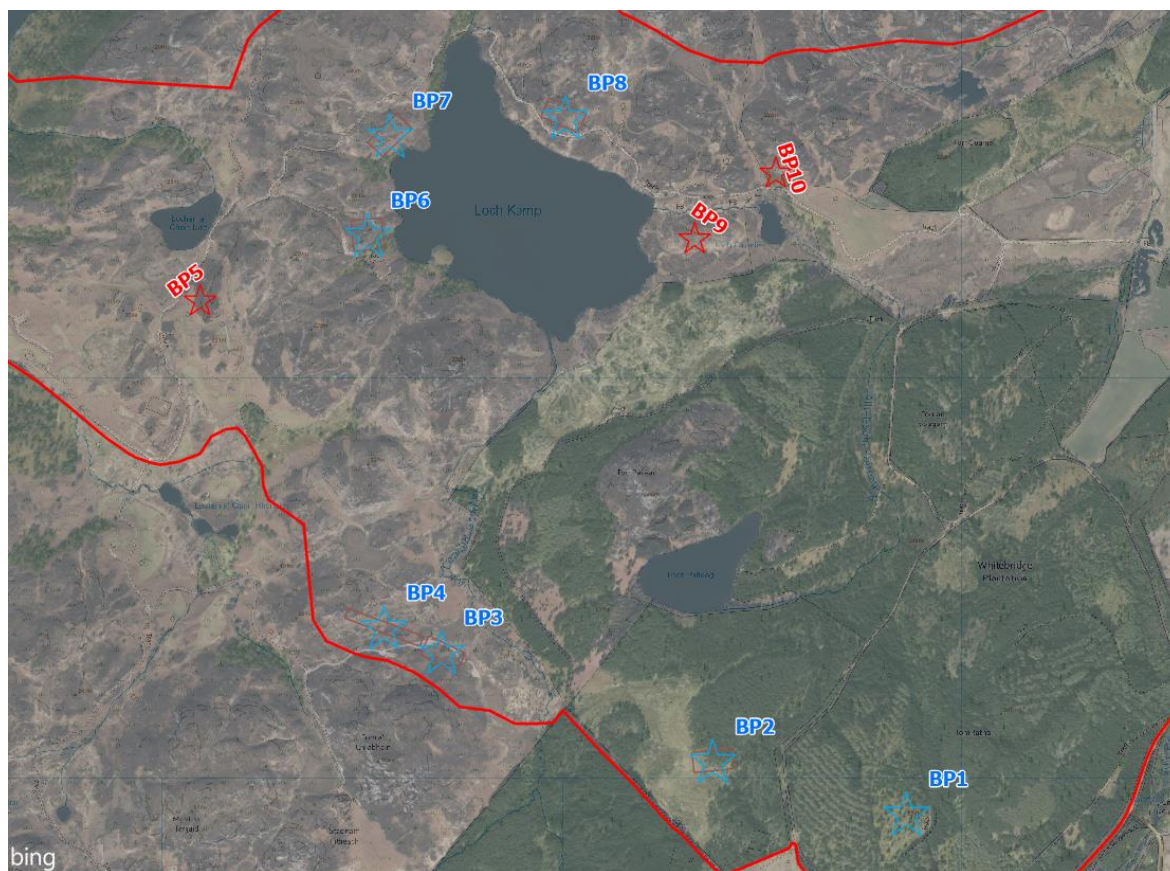
Figure 6 : Proposed borrow pits locations at the Revised Development

The proposed locations of the potential borrow pits suitable for use in the Revised Development are displayed in Figure 6 with borrow pits screened out denoted and labelled in red.

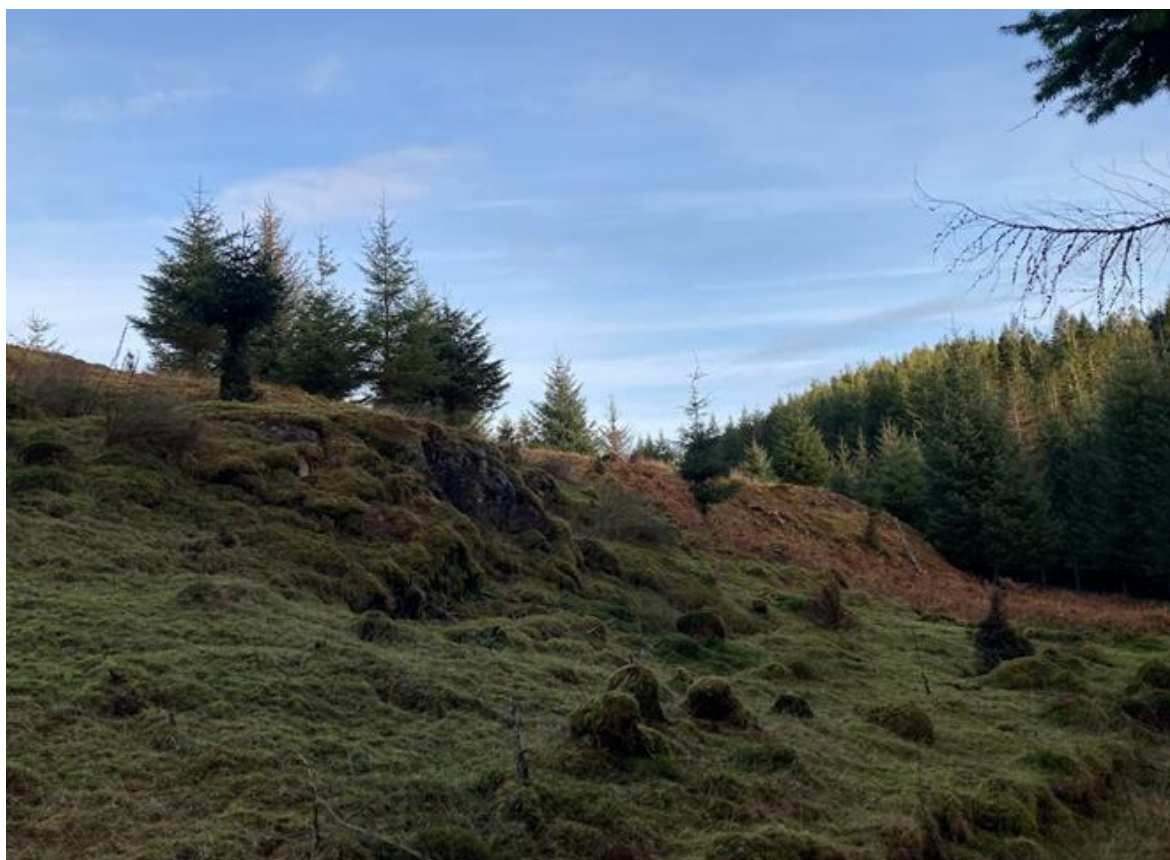
Figure 7: Location of borrow pit BP 1 (looking north)

The proposed location of BP1 is E: 247864, N: 814910, within a clearing of the forested area to the southeast of the Revised Development. It is located approximately 80 m from the planned 8 m wide access track which provides access from the B862 public road. It is anticipated that BP1 would be critical in providing rockfill for initial site access track construction, and upgrading where existing tracks can be used, in order to facilitate construction access to other project structures.

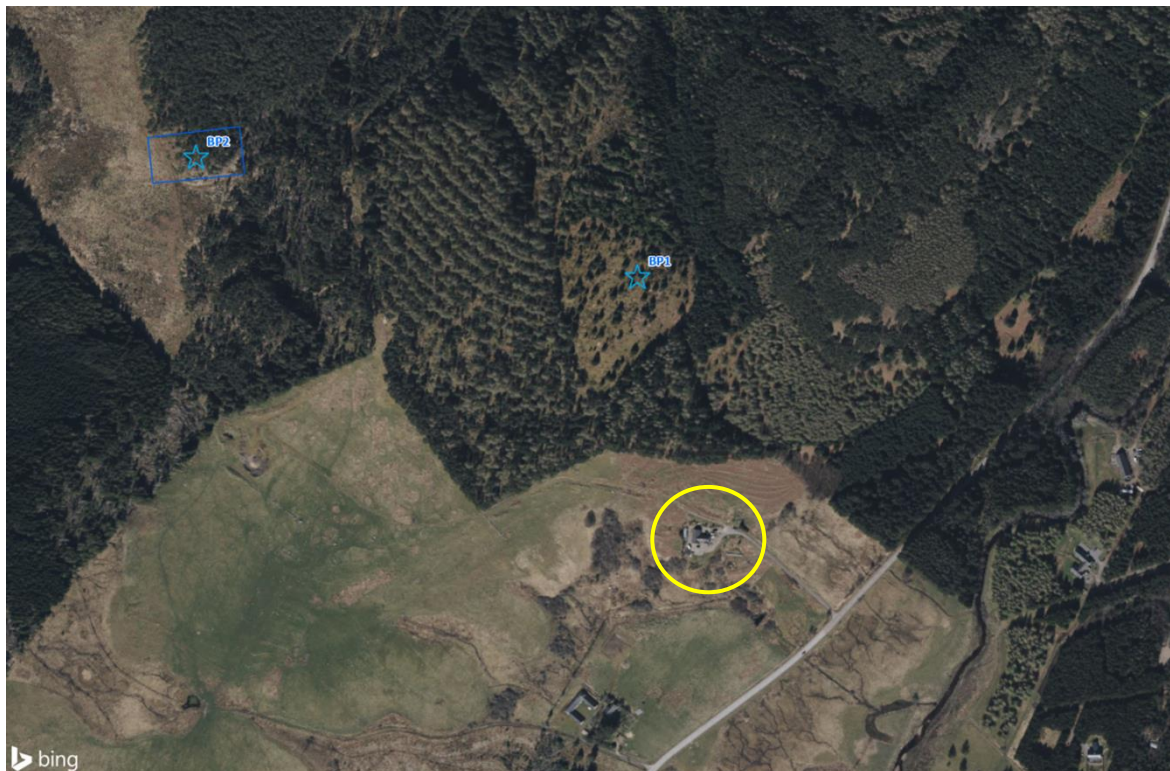
Figure 8: Location of borrow pit BP1 and proximity to residential receptor (within yellow circle).

Approximately 250 m southeast of BP1 is an existing lodge/private accommodation, highlighted in Figure 8. The impact of the Revised Development has been considered at this receptor within the EIA, with particular respect to noise, dust and air quality.

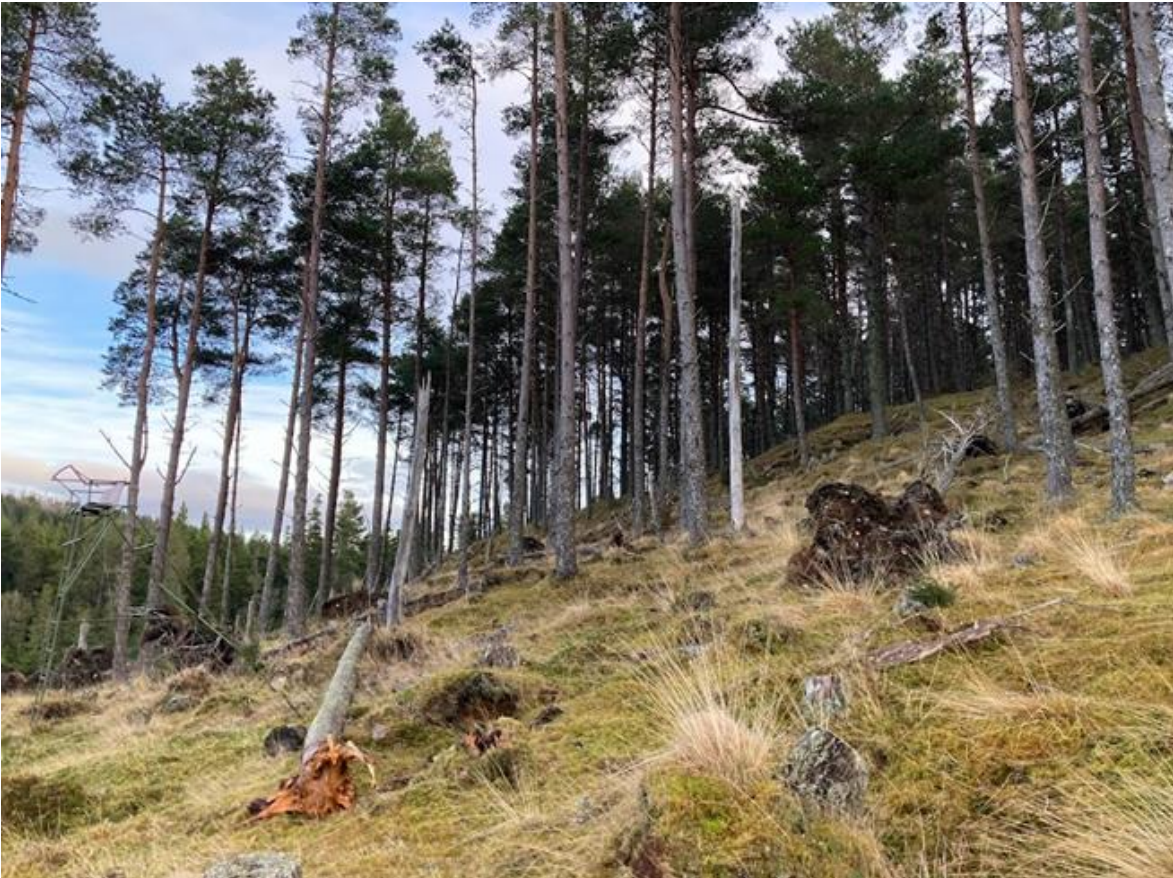
Figure 9: Location of borrow pit BP2 (looking northeast)

The proposed location of BP2 is E: 247379, N: 815043, close to a forested area to the south of the Revised Development. It is located approximately 200 m from the planned 8 m wide access track from BP1.

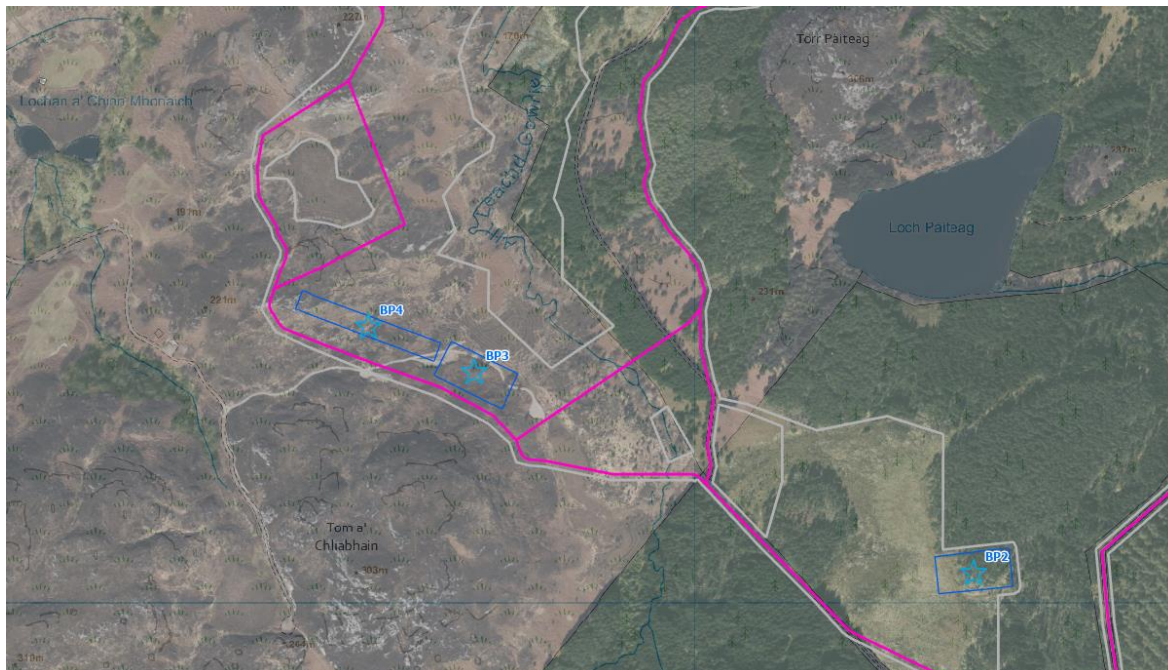
Figure 10: Aerial showing proposed layout dimensions of borrow pits BP2, BP3 & BP4

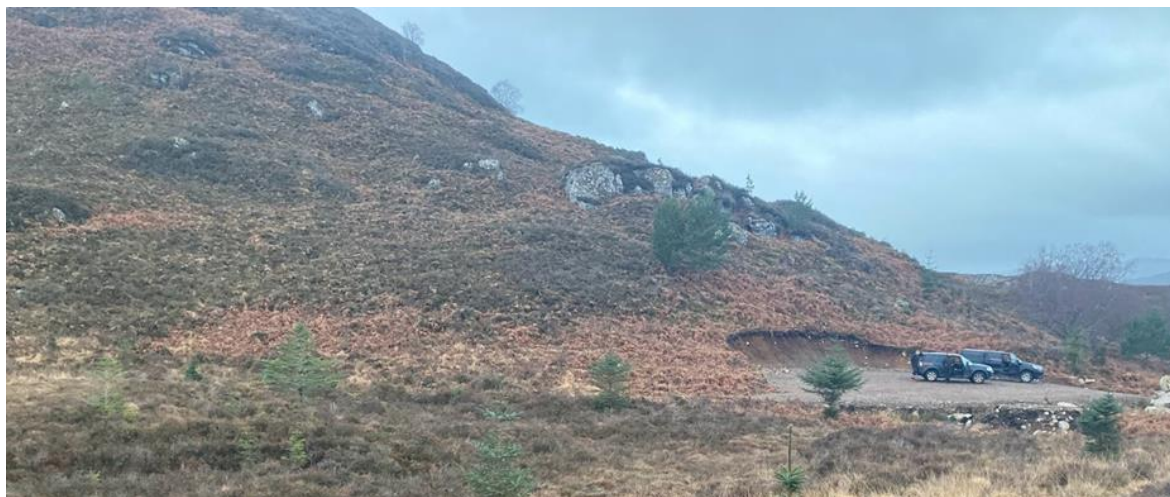
Figure 11: Location of borrow pit BP3 (looking west)

The proposed location of BP3 is E: 246703, N: 815315 to the south of the Revised Development, immediately north of a raised rock outcrop area. BP3 is immediately adjacent to the planned 8 m access track and resides within the planned upper reservoir inundation area.

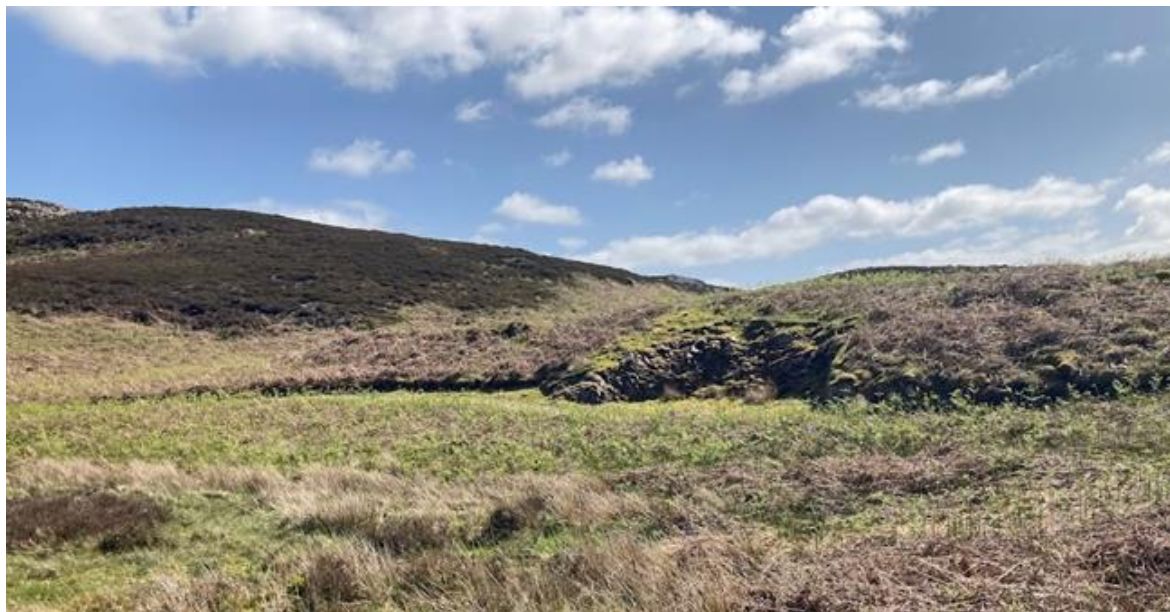
Figure 12: Location of borrow pit BP5 (looking east)

As displayed in Figure 12, it is a predominantly flat terrain at BP5 however, to the west of BP5 is the steep slope descending to the shoreline of Loch Ness through Ness Woods Special Area of Conservation (SAC) designated site. As the flat terrain presents no sloped rock mass to cut into, the excavated area at BP5 would be significantly larger than at alternatives available within the Revised Development. Furthermore, the steep slope to Loch Ness to the west means that any excavation works would be highly visible within the surrounding landscape and from the Great Glen Way walking route. Therefore, it is proposed to screen out BP5 due to landscape and visual reasons, proximity to environmental receptors and the availability of more suitable locations within the Revised Development.

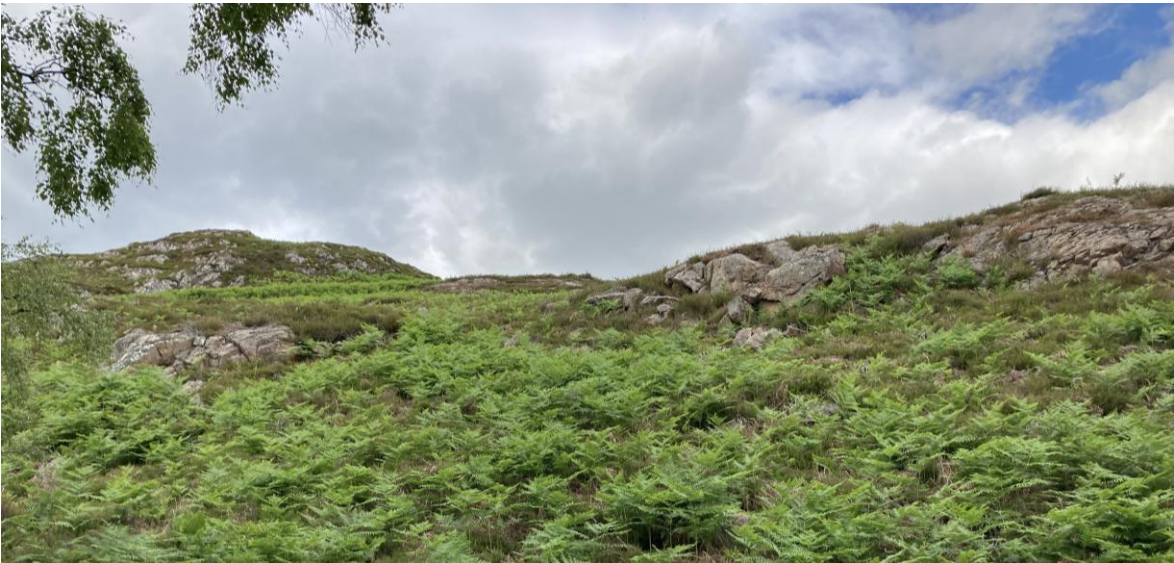
Figure 13: Location of borrow pit BP6 (looking west)

The proposed location of BP6 is E: 246516, N: 816356, to the immediate west of the existing Loch Kemp reservoir and south of the proposed intake structure location for the Revised Development. Additionally, BP6 resides within the proposed upper reservoir inundation area. The bedrock formation at BP6, is Psammite, Pebbly belonging to Gairbeinn Pebbly Psammite Member (GAIR-PSAP) with an anticipated surface peat depth is around 0 - 0.5 m.

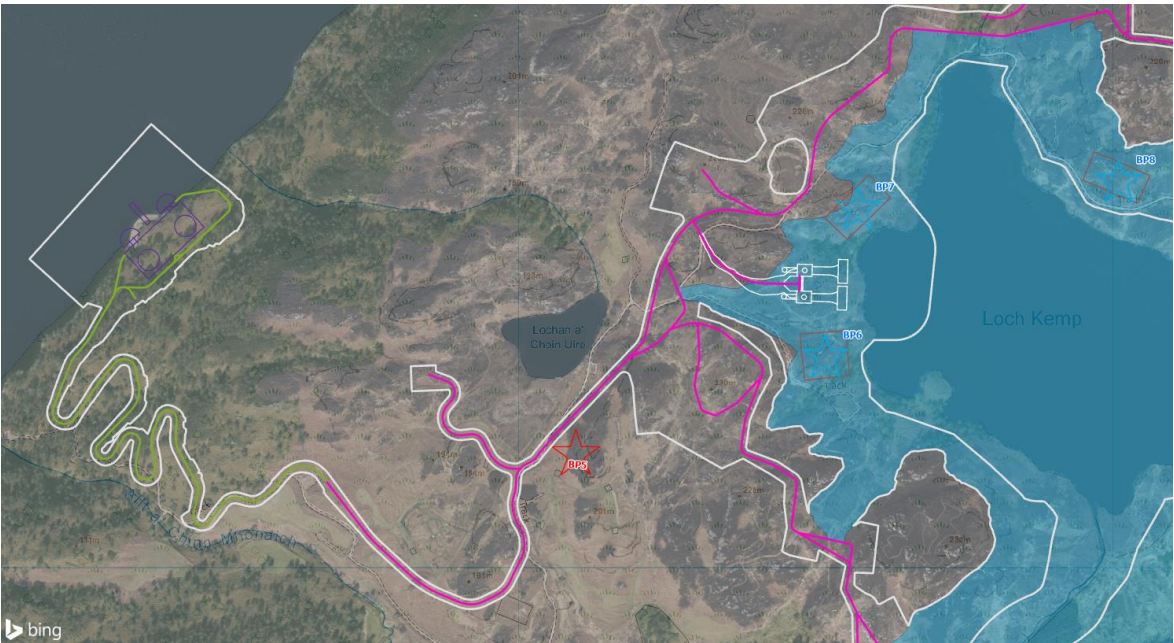
Figure 14: Aerial view showing proposed layout dimensions of borrow pits BP6, BP7 & BP8

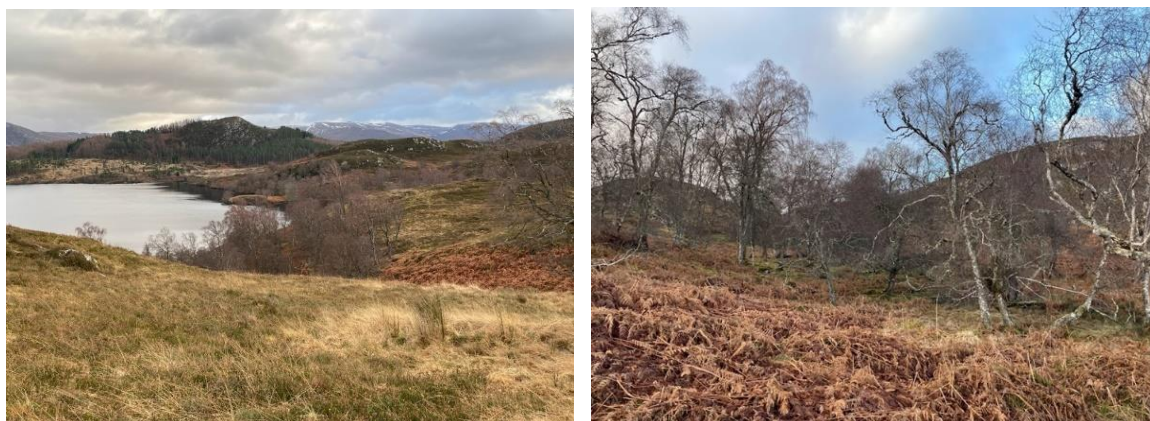
Figure 15: Location of borrow pit BP7 (looking west and east respectively)

The proposed location of BP7 is E: 246573, N: 816606, to the immediate west of the existing Loch Kemp reservoir and north of the proposed intake structure location for the Revised Development. Similarly to BP3 and BP6, BP7 resides within the planned upper reservoir inundation area. The bedrock formation at borrow pit BP7 is again Psammite, Pebbly belonging to Gairbeinn Pebbly Psammite Member (GAIR-PSAP) with an anticipated surface peat depth is around 0 - 0.5 m.

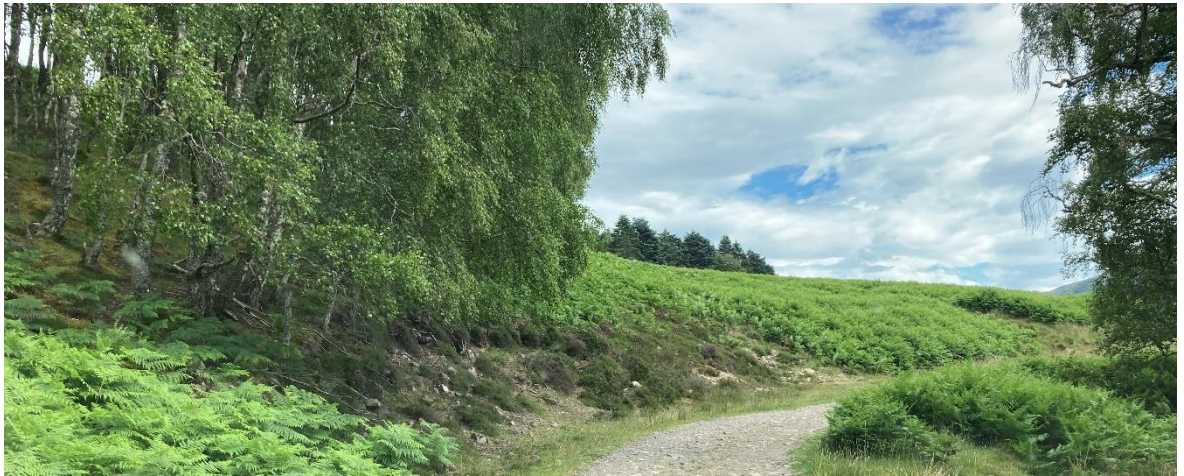
Figure 16: Location of borrow pit BP9 (looking east)

The proposed location of BP9 is E: 247537, N: 816512, to the northeast of the Revised Development in a small, forested area adjacent to an existing estate access track. The bedrock formation at BP9 is Granodiorite belonging to Foyers Igneous Complex (FOY-GD) with an anticipated surface peat depth is around 0 - 0.5 m. However, site visits indicate that the material at BP9 is representative of glacial till deposits of an unknown depth which do not provide suitable physical and mechanical strength for use in project structures at the Revised Development. Furthermore, mapped bog areas were identified on site in close proximity to the proposed BP9 location (pink areas shown in Figure 17) whilst it would also be located in close proximity to forestry regeneration areas (green areas shown in Figure 17). Therefore, it is planned to screen out BP9 due to its unsuitability for rockfill provision, environmental constraints and the availability of more suitable locations within the Revised Development.

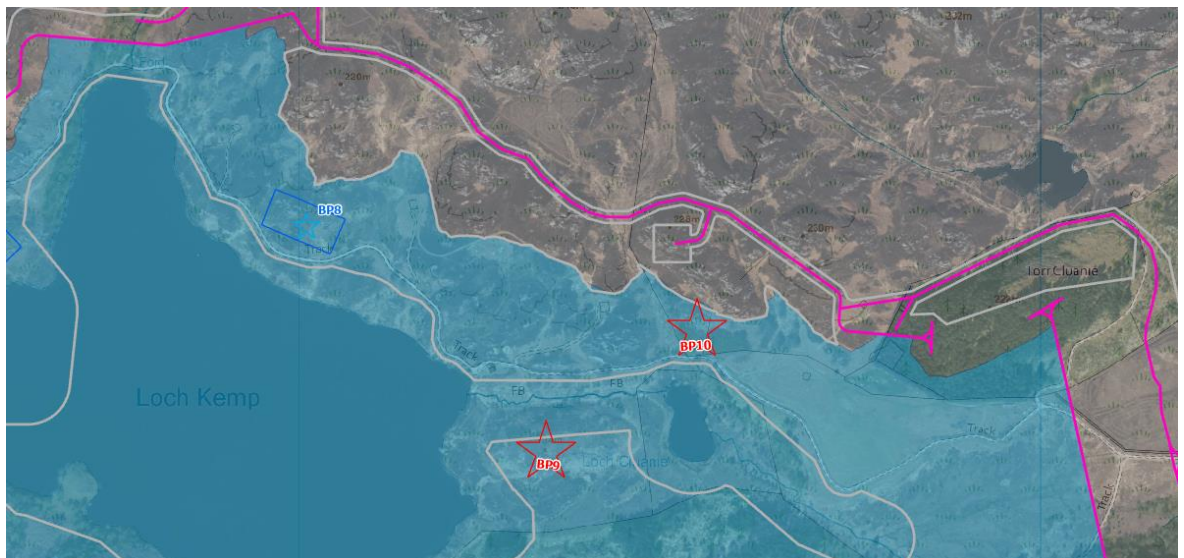
Figure 17: Plan view showing proposed layout dimensions of BP8 and locations of BP9 & BP10

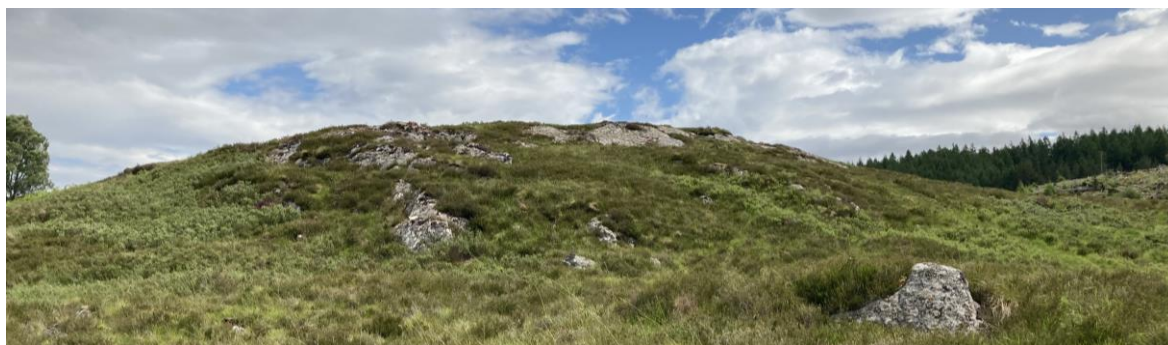
Figure 18: Location of borrow pit BP10

The proposed location of BP10 is E: 247333, N: 816346, to the northeast of the Revised Development, adjacent to an existing estate fishing lodge. The bedrock formation at BP10 is Granodiorite belonging to Foyers Igneous Complex (FOY-GD). BP10 is shown in peat mapping as being in close proximity to deep peat areas (peat depth >3m) whilst areas of peat depth of 1 – 2 m are abundant in this area east of the existing Loch Kemp reservoir. In addition, site visits have also indicated significant peat areas in the vicinity of BP10. Therefore, it is planned to screen out BP10 due to potentially significant peat removal requirements and the availability of more suitable locations within the Revised Development.

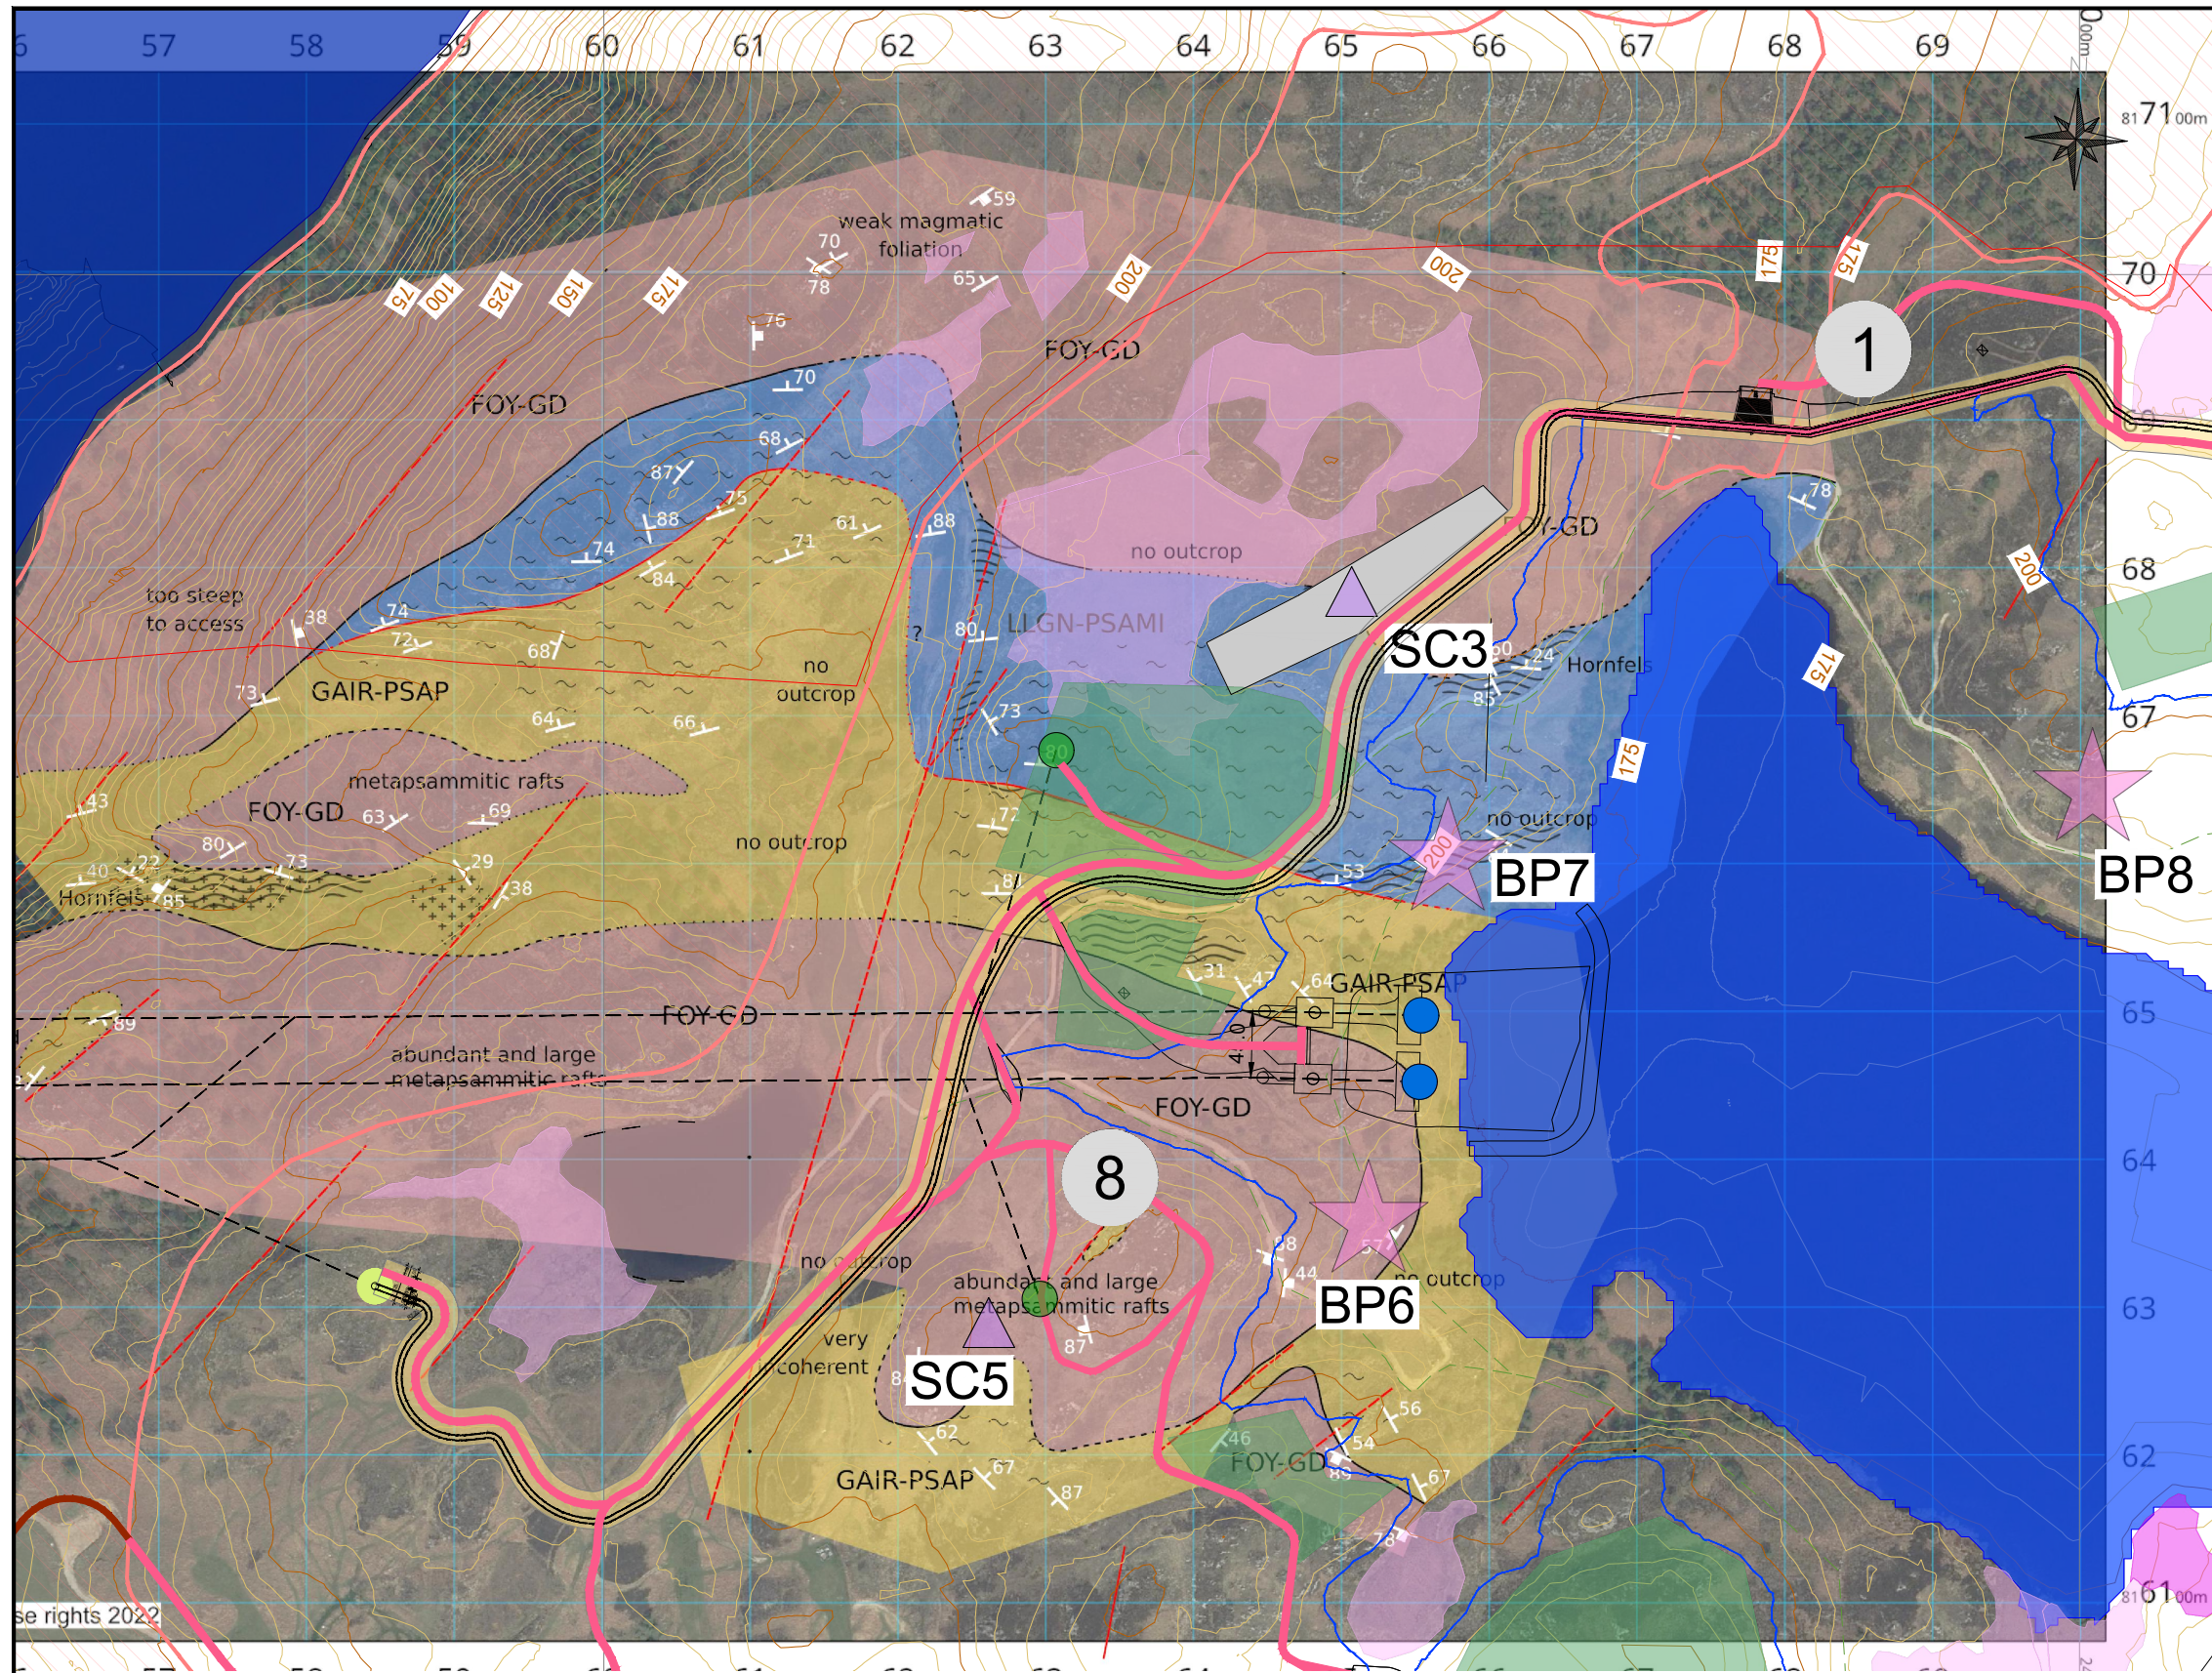
Annex 1
Borrow Pit
Overview with Geological Map

- Dominant foliation (S0/S1, dip direction/dip)
- Joints (dip direction/dip)
- Gneissic
- Contact metamorphic/hornfels
- Melt impregnation
- Loose boulders in colour of lithology

- Foyers Igneous Suite Granodiorite (FOY-GD)
- Loch Lagan Psammite Formation (LLGN-PSAMI)
- Gairbeinn Pebbly Psammite Member (GAIR-PSAP)
- Moine Supergroup Psammite (M-PSMY)
- Lithological contacts (observed, inferred, suspected)
- Tectonic contact (observed, inferred, suspected)
- (Tectonic) lineament mapped on aerial photograph

Based on the available geological and surface mapping in conjunction with the prominent topographic steps (depressions) in the terrain, a number of geological structures (faults, shear zones) have been identified at the Revised Development. The tentative placement of the faults can be seen on the geological map displayed in Appendix A.

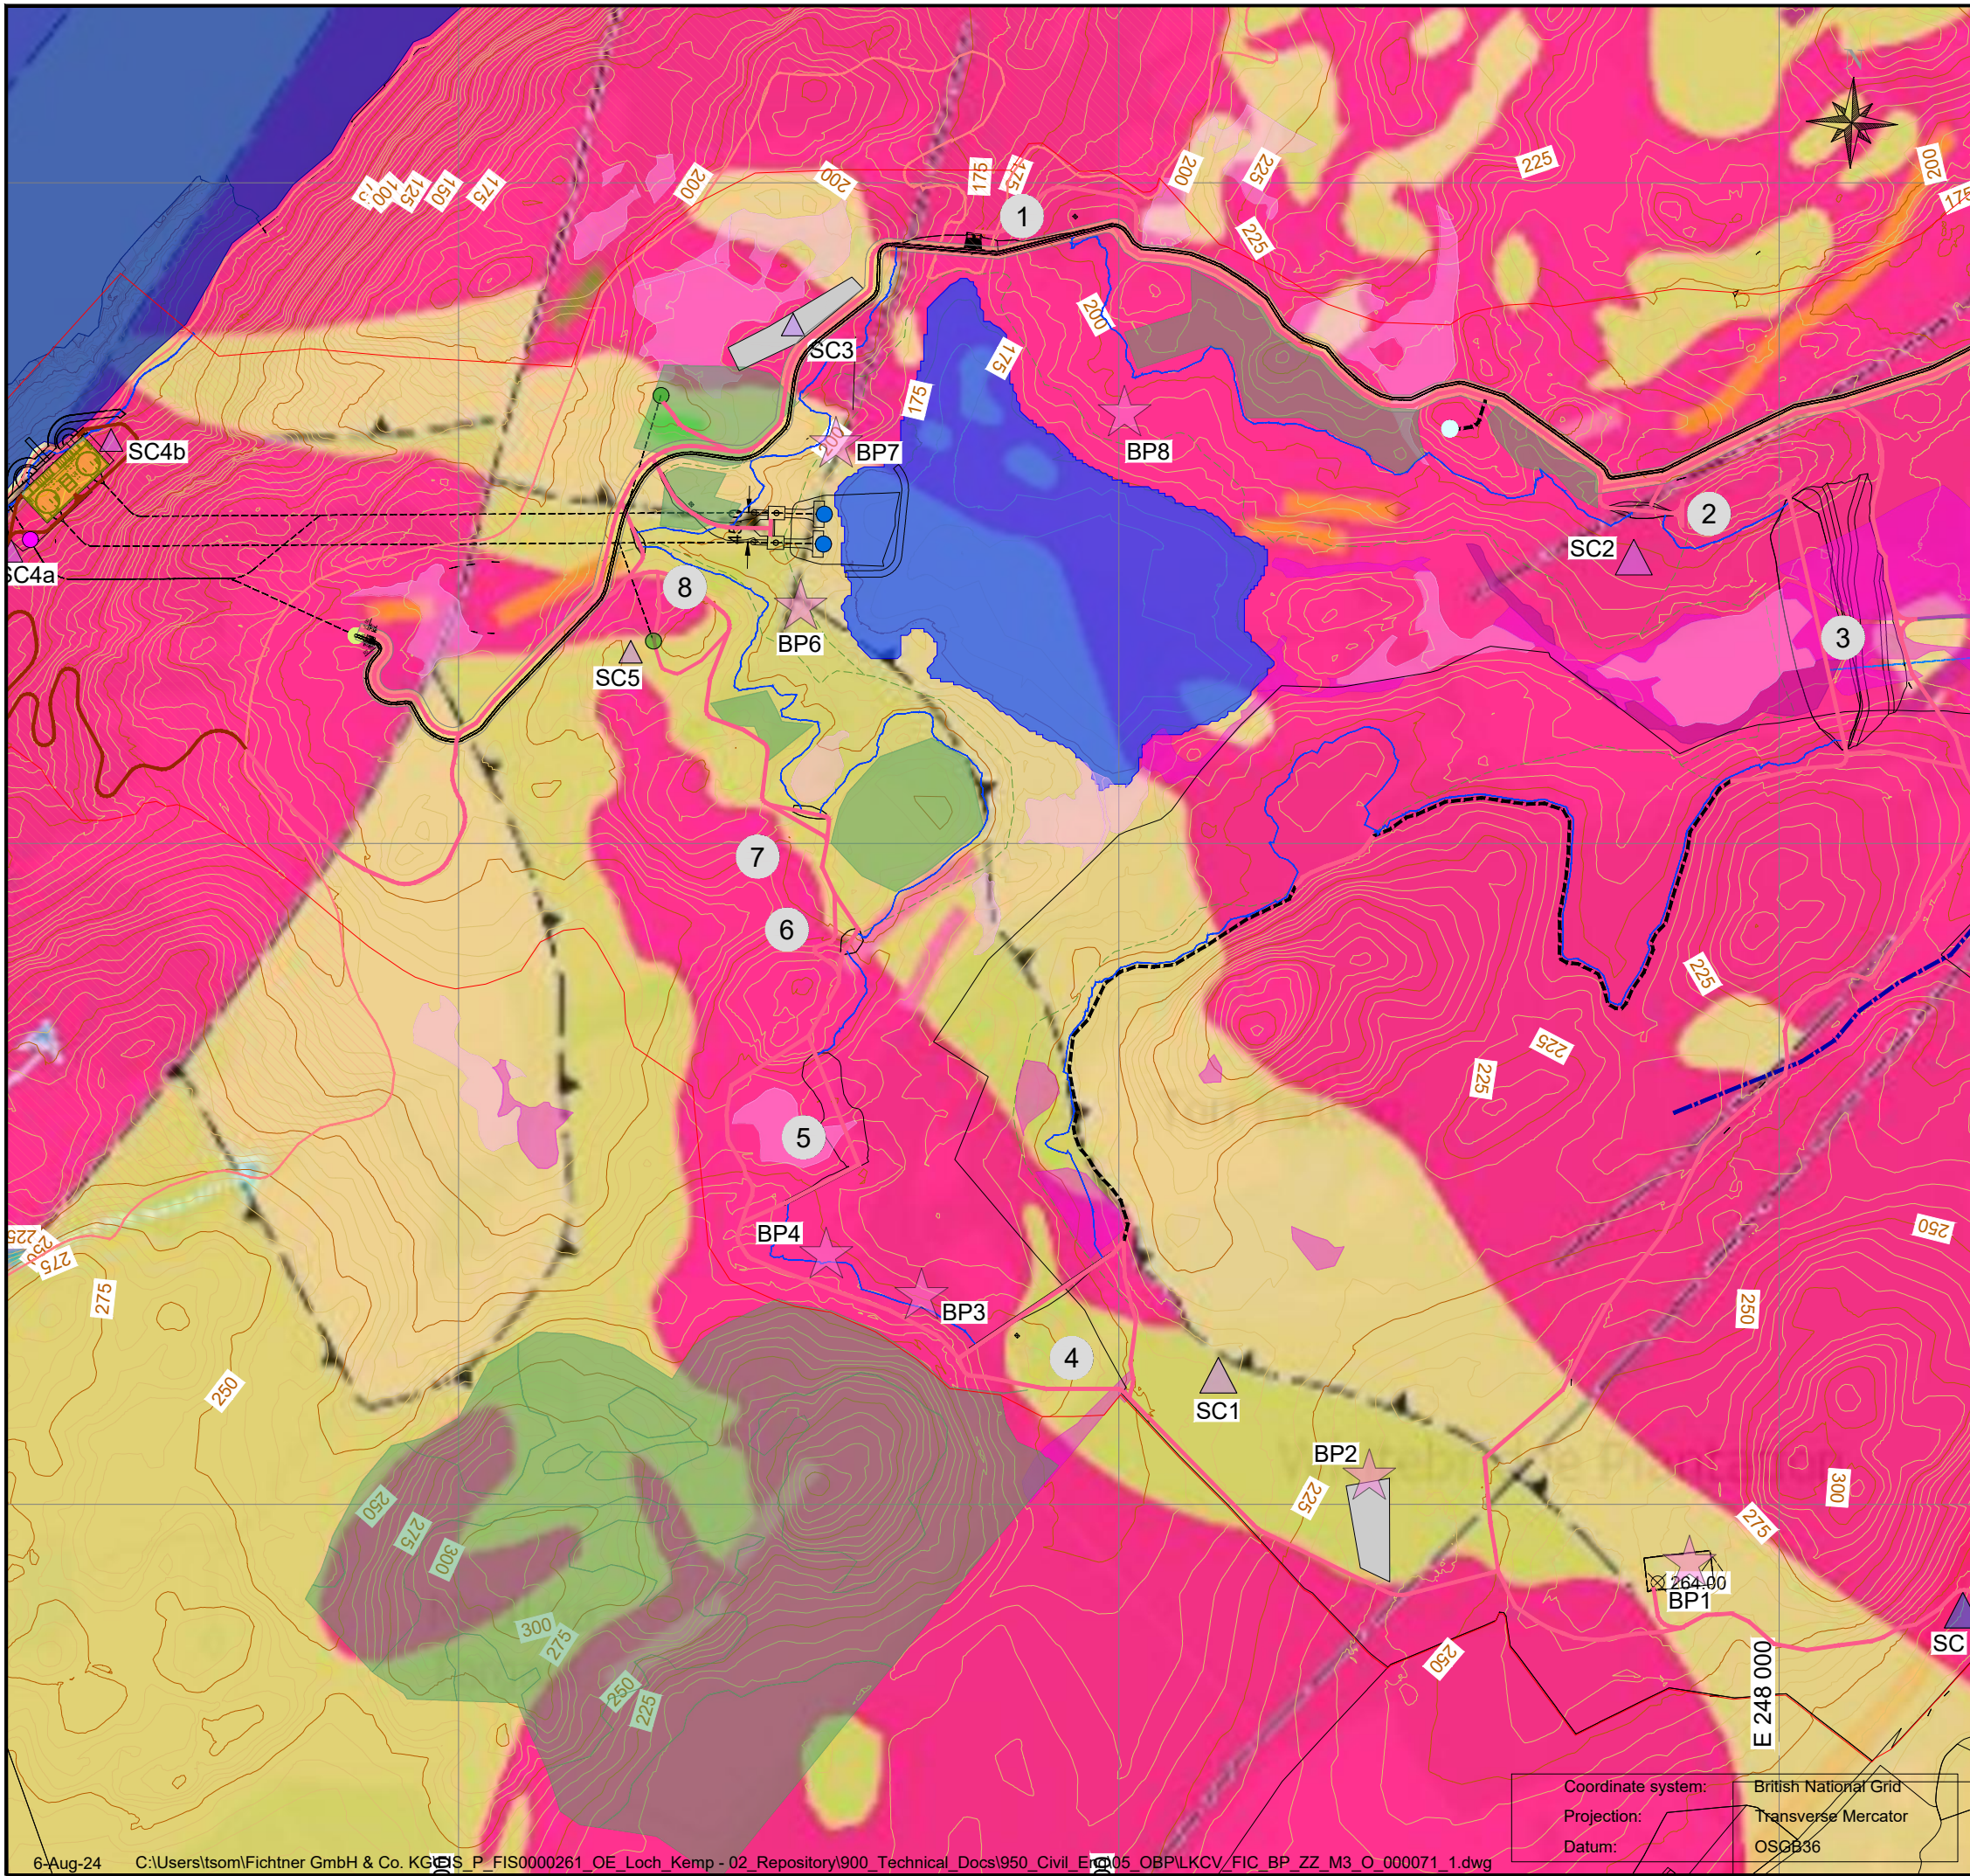
Bedrock geology 1:50,000 scale

- NORTH BRITAIN SILURO-DEVONIAN CALC-ALKALINE DYKE SUITE - MELAMICRODIORITE
- ACHNACONERAN STRIPED FORMATION - PSAMMITE AND SEMIPELITE
- FOYERS IGNEOUS COMPLEX - MICRODIORITE
