Loch Kemp Storage - EIA Report (Additional Information)

AI Appendix 3.5: Draft Borrow Pit Screening Assessment (Revised)

September 2024

Borrow Pit Screening Assessment

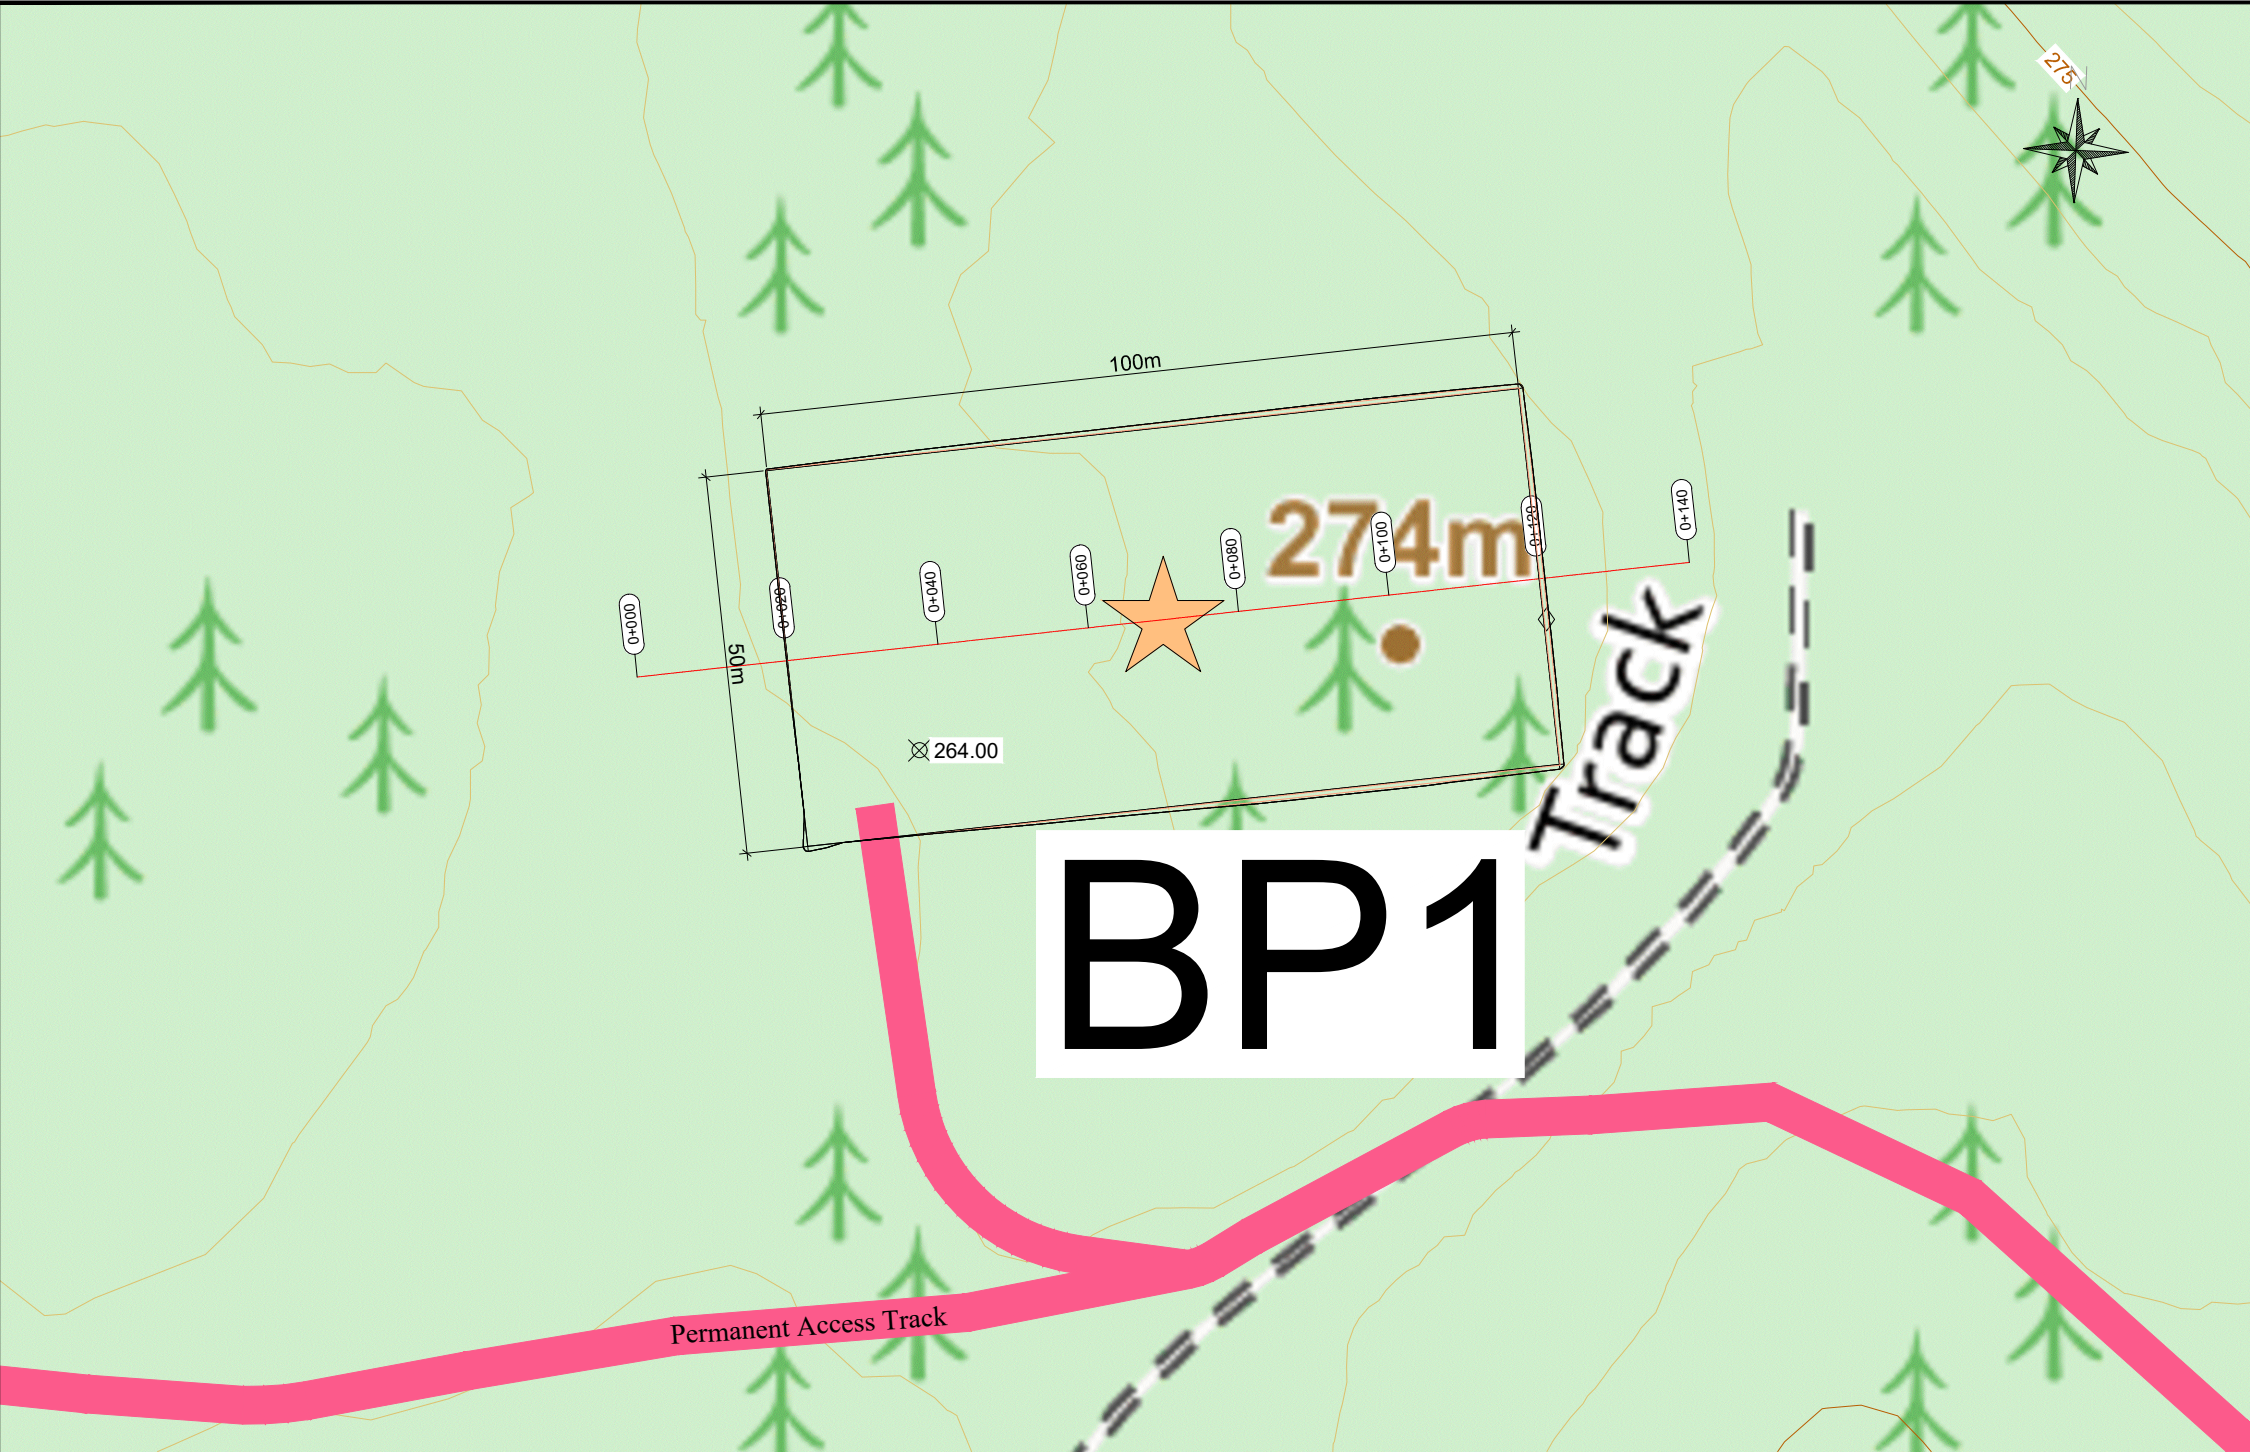
C Borrow Pit Dimensions

- Assumed Overburden Depth: 1m
- Excavation Slope h:v=1:10
- Rock Excavation Volume:
BP1: 26,100 m³

Physical Characteristic	Value
Maximum site dimensions (L x W x D)	100 m x 50 m x 10 m
Platform elevation	264 m AOD
Maximum elevation	277 m AOD
Excavation volume	c.26,100 m ³
Terrain conditions	The terrain is flat in NS and EW direction (<1%)
Extraction methodology	Ripping and blasting

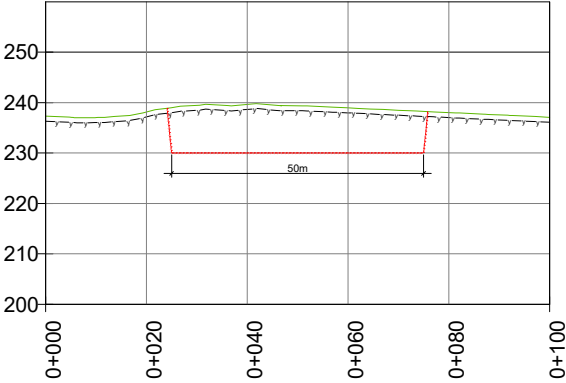
Cross Section of BP2

- NOTE:
- Assumed Overburden Depth: 1m
 - Excavation Slope h:v=1:10
 - Rock Excavation Volume:
 - BP2: 36,700 m³
 - BP3: 43,740 m³
 - BP4: 26,000 m³

Based on the available geological and topographical information at the location of BP2, a maximum potential excavation volume of c.36,700 m³ is anticipated at BP2. Indicative sections and dimensions for excavation at BP2 are provided in Appendix C.

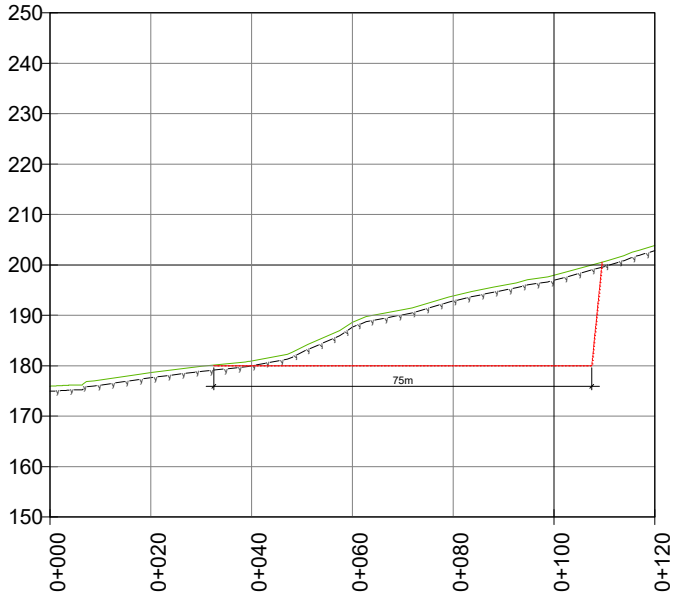
Cross Section of BP6

- NOTE:
- Assumed Overburden Depth: 1m
 - Excavation Slope h:v=1:10
 - Rock Excavation Volume:

BP6: 48,600 m³
BP7: 65,270 m³
BP8: 34,060 m³

Based on the available geological and topographical information at the location of BP6, a maximum potential excavation volume of c.48,000 m³ is anticipated at BP6. Indicative sections and dimensions for excavation at BP6 are provided in Appendix C.
